## Ivie 1026-IF Wiring Diagram

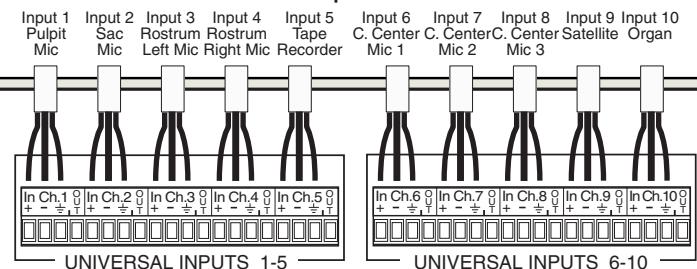
## – Inputs

— UNIVERSAL INPUTS 1-5 —

— UNIVERSAL INPUTS 6-10 —
